PERFORMANCE VERSUS SAFETY OF SOME PRIMARY AND RECHARGEABLE LITHIUM BATTERIES

The performance and safety of selected portable, military batteries is discussed, with emphasis on extreme physical and electrical abuse tests, such as nail penetration and overcharging. The battery couples discussed are the lithium-sulphur dioxide and lithium-manganese dioxide non-rechargeable systems plus the nickel-metal hydride and lithium-ion rechargeable systems.

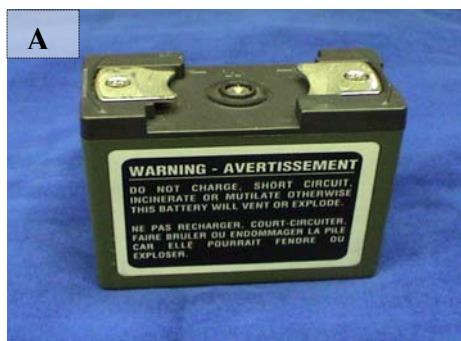
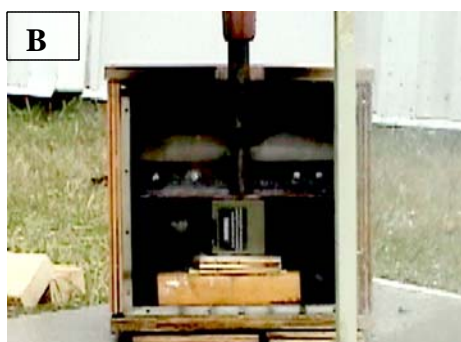
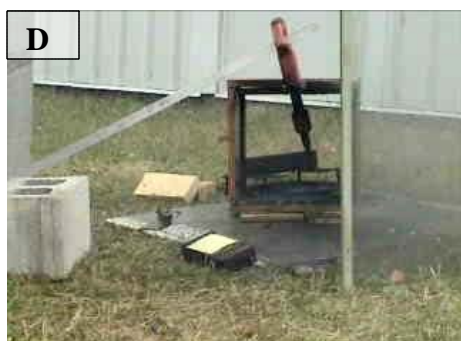
Figure 3. A. Photograph of a BA-521 battery; B. a lithium-thionyl chloride version of the battery in the nail test apparatus. C. the battery exploding (see text). D. the damaged apparatus.

A prototype BA-521, which contained lithium-thionyl chloride cells was offered to the CF for evaluation. This couple has very good low temperature performance but there are safety issues with the spirally wound cells. A nail test was performed on this prototype battery and it immediately caught fire and emitted thick white choking fumes of hydrogen chloride (hydrochloric acid). The fire was put out but, 5 minutes later the battery exploded violently, severely damaging the nail test apparatus (see Fig. 3). What had happened here was that the nail had penetrated 2 or 3 cells of one of the 4-cell strings of the battery, while the other string was left undamaged. However, the heat generated by the short-circuit had eventually been conducted to the good cells and, when the melting point of lithium metal had been reached, these cells reacted violently. This is an important aspect to remember when encountering a vented or damaged battery in the field – some of the cells may still be live and plastic insulation on the cells and connecting wires may have been burned away such that a short-circuit could be activated by disturbing the battery.

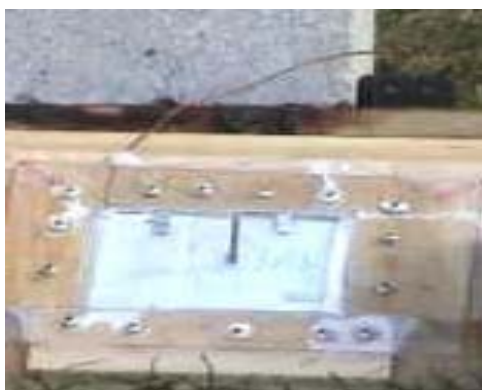
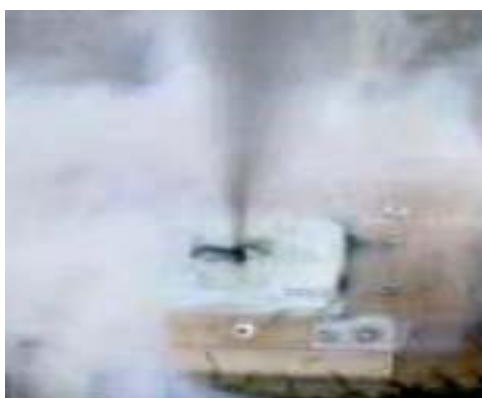
Figure 7. Nail penetration of a lithium-ion gel-polymer cell constrained under a 0.09" sheet of Lexan plastic. Top: 1 second after penetration. Bottom: 3 seconds later.

Nail penetration of fully charged cells was carried out using a long metal rod with a hollow tip to push the nail into the cell from a distance. With a freestanding cell, there was an immediate increase in pressure and the cell ruptured and later caught fire. It was also found that the cells could be caused to short-circuit and emit copious white fumes by stabbing them with a ballpoint pen. Therefore, these cells are very sensitive to impact by sharp objects, as opposed to blunt objects. However, when a 50% charged cell was subjected to nail penetration, it was safe; there was no expansion of the pouch due to an increase in internal pressure and the temperature remained relatively low. Nail penetration was also carried out on pouch cells that were constrained, in order to simulate what could happen with cells inside a battery case. For these tests, a wooden base was used, and a 0.09" thick sheet of clear plastic (Lexan) was screwed into the wood to hold the cell down, with silicone used as a sealant. The set-up can be seen in Fig. 7. With nail penetration,

there was a large build-up of pressure and the nail was ejected from the cell along with large amounts of white fumes mixed with black particles. However, the cell did not catch fire in this case.
